Service Bulletin: Headset play / Wrong headset preload

Correct preload of carbon fork headsets

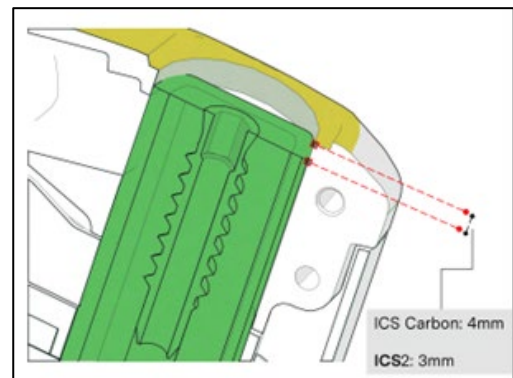
1. Make sure that the steerer tube is cut correctly. To ensure correct preload of the headset, the steerer tube must not touch the top cap.

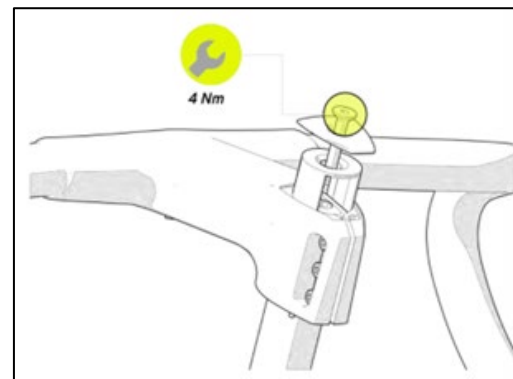
2. Torque the expander bolt as specified. For combinations of carbon fork and ICS, the torque is always 4 Nm.

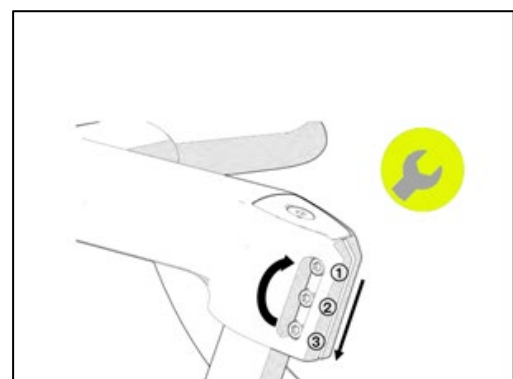
3. Tighten the stem clamping bolts as specified.

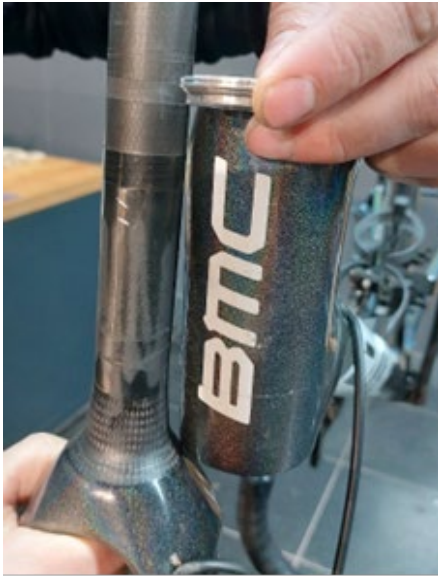
If a bike re-develops headset play quickly after it was adjusted, check the fork steerer for marks as in the pictures below. These marks are a direct result of riding with headset play. In such case, the fork must be replaced.

Marks on a round steerer tube.
Metal split ring.

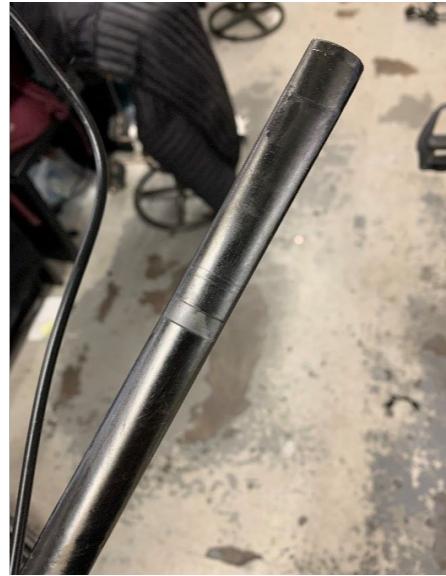
Marks on a flat steerer tube.

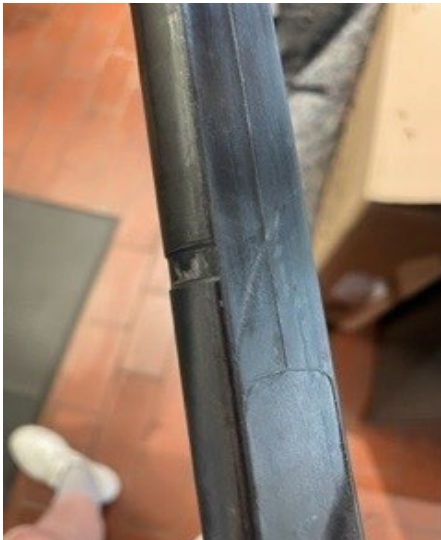
Deep wear on a flat steerer tube.
This fork must no longer be ridden!

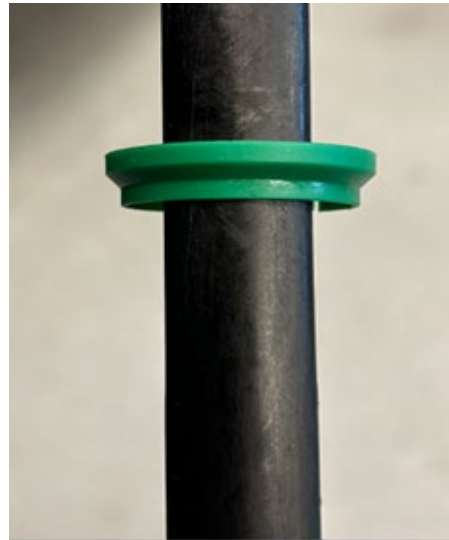
Plastic split ring
